**GLEN ELLYN PARK DISTRICT
FRANK JOHNSON CENTER
FACILITIES MASTERPLAN**

Facilities Master Plan

September 24, 2021

This existing facility condition review identifies deficiencies and defects of site and building that may impact current or future operations. The review was performed in general conformance with ASTM E 2018 - 15, Standard Guide for Property Condition Assessments: Baseline Property Condition Assessment Process.

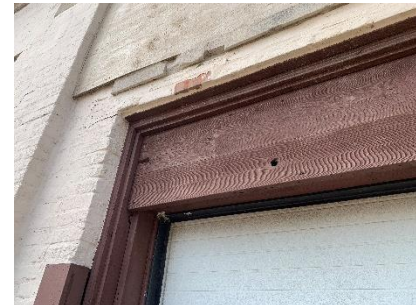
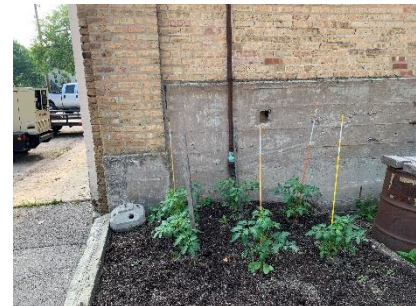
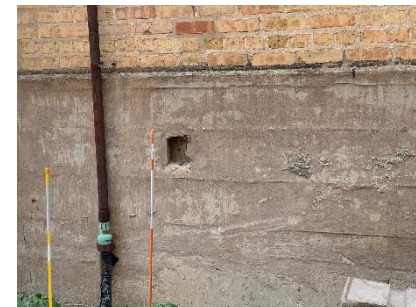
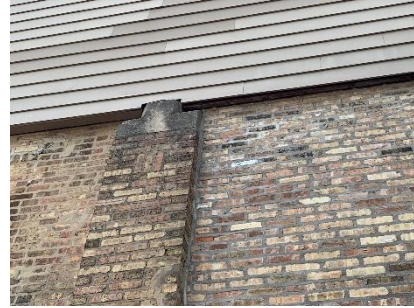
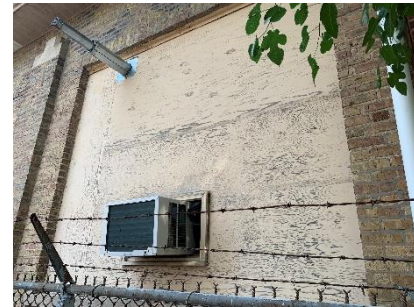
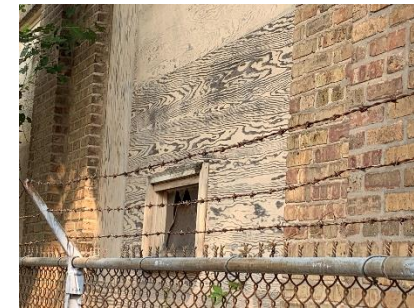
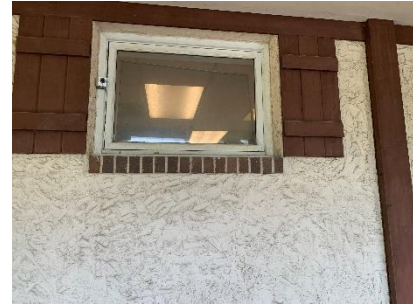
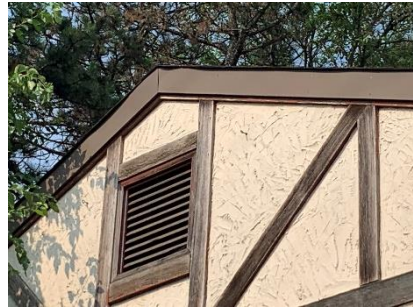
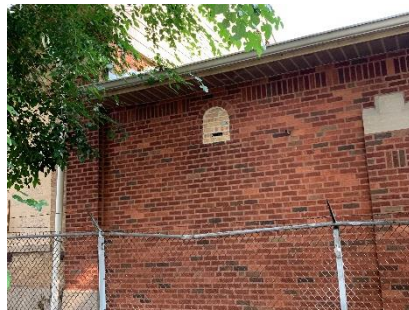
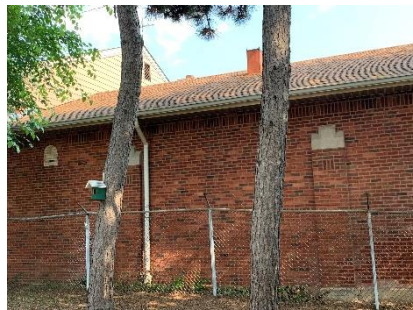
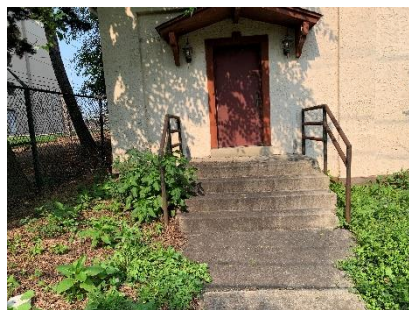
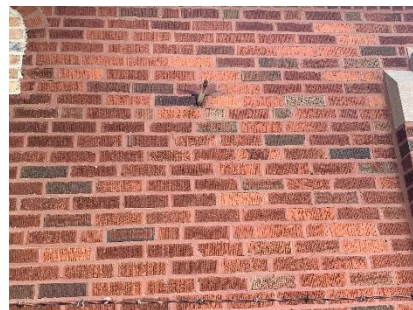
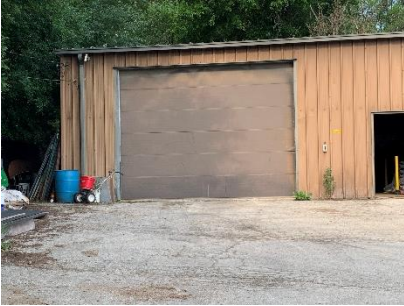
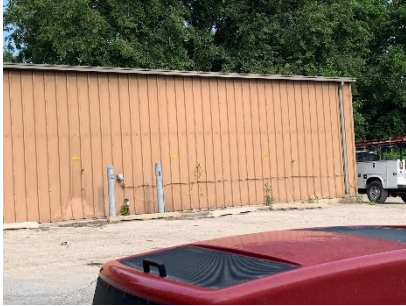
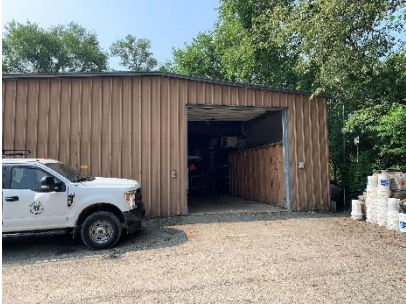
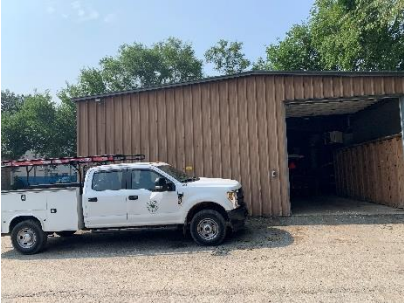
EXTERIOR WALLS

The original structure consists of exterior load bearing 3 wythe thick masonry walls with masonry buttresses along the north, south and west facades. The shop portion of the structure consists of a painted/ exposed common brick exterior finish. The following photos in section 3.1 will identify specific areas of deficiency. The overall exterior wall on the main building is in fair to poor condition, areas of cracked brick, missing bricks, multiple open masonry joints, spalling concrete were all observed. Additional information will be discussed in Section 5. The western masonry façade on the main building appears to be bowing and bulging outward. Exterior siding appears to be oil canning and missing in several locations. Exterior paint is flaking and cracking along all exterior jambs. Complete removal of paint, proper priming and reapplication will be required. Plywood infill panels along the southern façade appear to be rotting and failing in various areas. Window on south façade is broken. Exposed glass should be removed.

The eastern office portion of the structure exterior wall make up is a stucco and wood façade with clay fired masonry face brick. Efflorescence was observed on the southern portion of the office area. Wood timbers appear sun faded but in good condition. Stucco finish appears in good condition. Failed sealant around windows was observed.

Exterior walls of storage garage to the west were observed to be in good condition. The exterior wall make up is a PBR metal panel and girt system with vinyl backed mineral wool insulation. Metal panels appear in good condition.

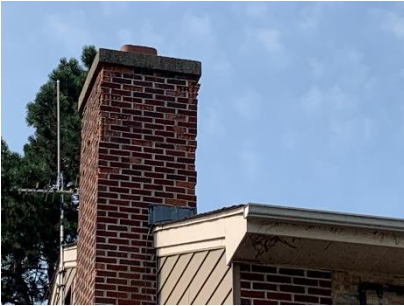
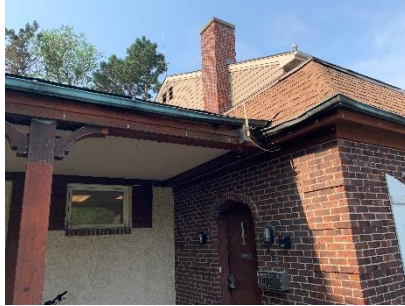
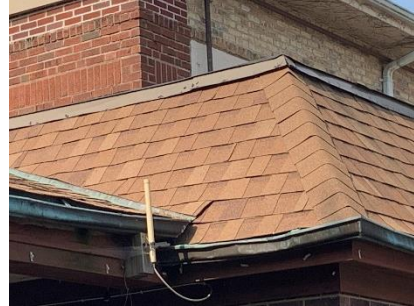
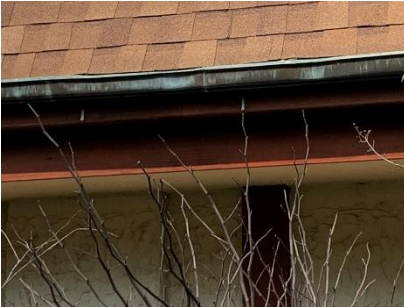
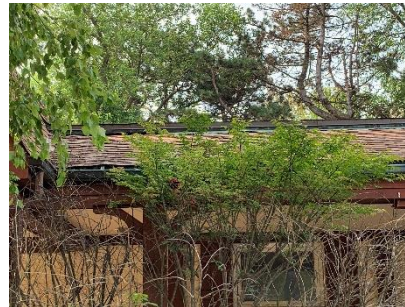
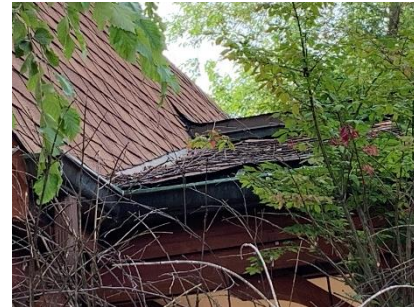
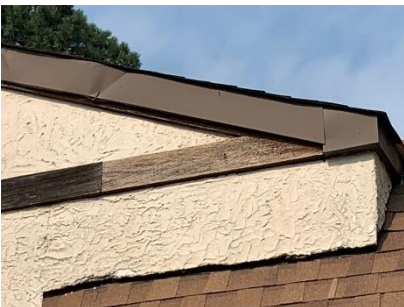
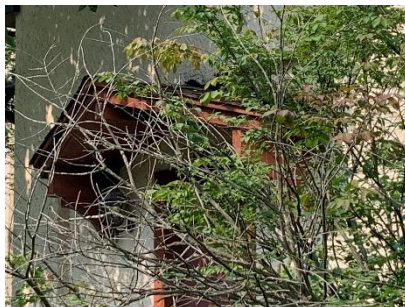
ROOF

The existing roof is a single ply of an asphaltic shingle on felt. Flashing and gutters on the single-story office appear to be copper which is commonplace for the time of the original building construction. No insulation was observed at time of visit. The evidence of various roof leaks was observed refer to Section 4 interiors for more information. The roof appears wavy and uplifting in multiple areas. A coring for moisture and full roof inspection is recommended to assess the roof substructure and potential moisture content of roof. Fascia's are damaged in various areas, and loose in others. Multiple downspouts are not connected and appears the gutters are blocked with debris to prevent proper roof drainage.

Based on these findings and the construction of the roof assembly, the roof's life expectancy is less than 5 years

All perimeter metal coping should be removed and replaced. Coping was installed without an improper installation per SMACNA details and requirements.

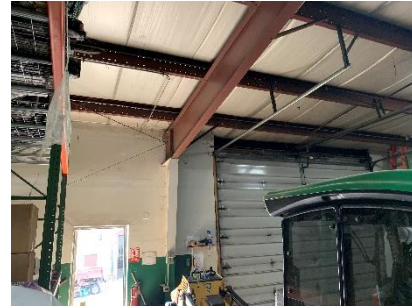
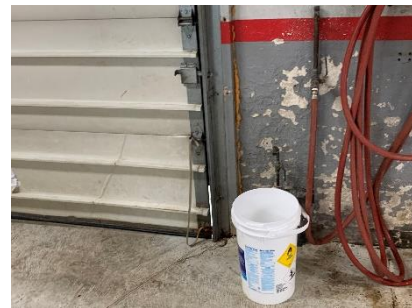
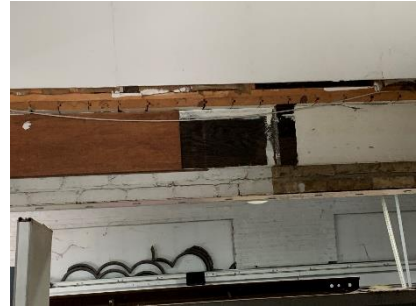
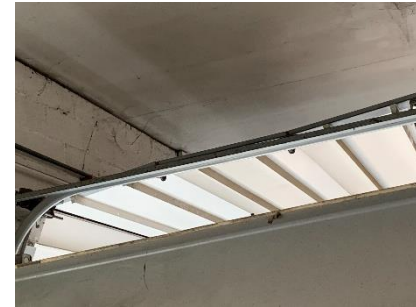
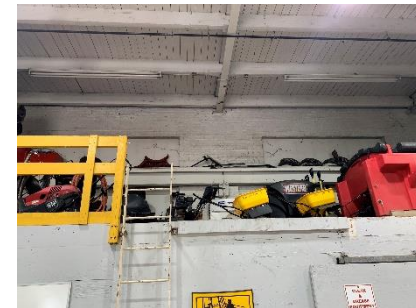
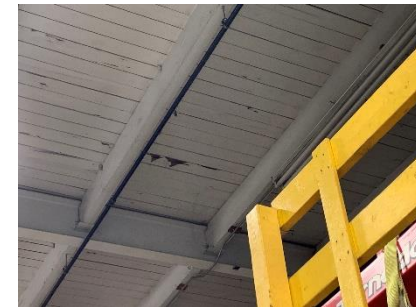
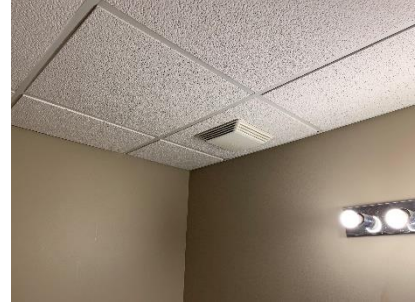
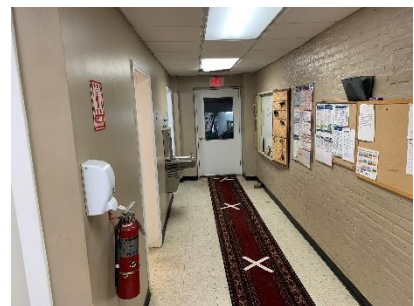
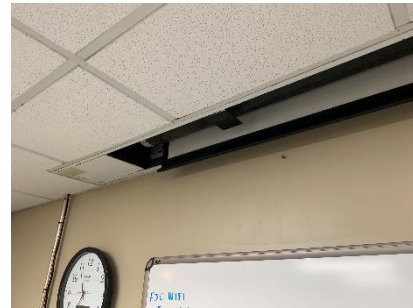
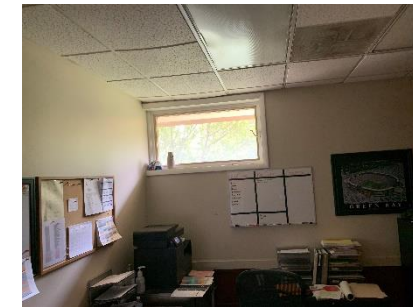
INTERIORS

The interiors of this building as observed demonstrated an extended life span of use. The existing shop concrete floor would benefit from a repair and replacement in multiple areas of the floor with an entire sealer on the floor recommended. The main shop has various levels of paint deficiency, from peeling and cracking to complete failure. The entire interior of the shop would benefit from a repaint.

The interior office interiors are in fair/poor condition. There are various levels of staining and damage to the existing floor surface. The interior ceiling tile system has failed in certain areas and are stained due to apparent water leaks. The ceilings in the damaged areas should be replaced to a good working order. Additional remedial work may be necessary once determination of the leaks are identified.

Interior doors are residential grade doors and show signs of damage and wear. We recommend installing commercial grade doors and frames.

Interior gypsum walls appear in good condition.

Residential case work is outdated in the break room but is in good working order.

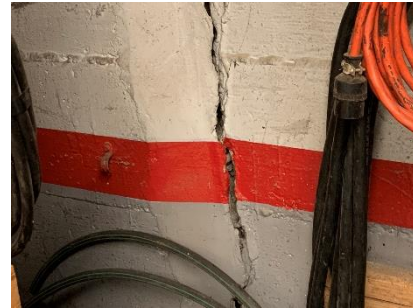
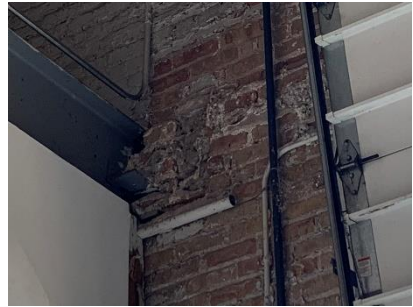
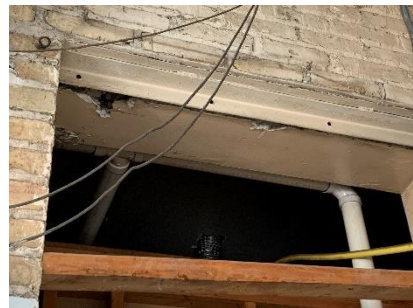
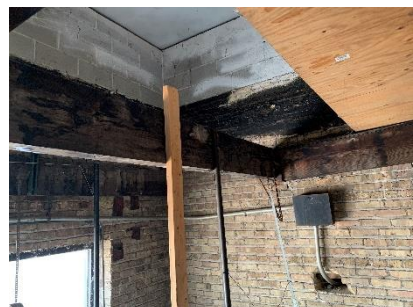
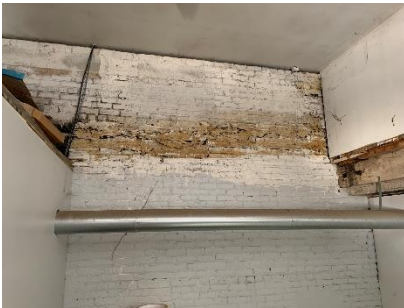
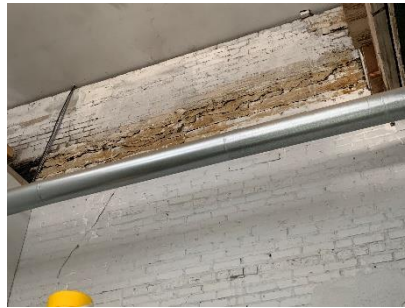
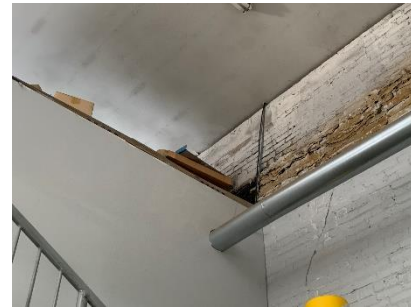
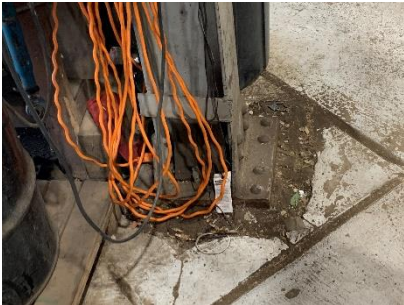
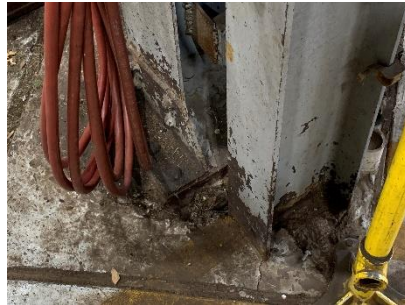
STRUCTURAL

The existing structure of the building appears to have deficiencies beyond the age and style of the building. We recommend a detailed review and analysis by a licensed structural engineer. Some observations noted in our review are as follows:

A differential crack was noted in the southwest corner of the shop. Remediation is required at this location.

Joint connections at the roof beams appear to be compromised. Remediation is required in this area.

Various cracking occurring at masonry beam supports in the existing masonry walls.

Various areas of water infiltration on the interior of the building are causing mortar wash out on interior.

Metal column base plates and columns are observed with layers of rust. The exact amount of decay is unknown.

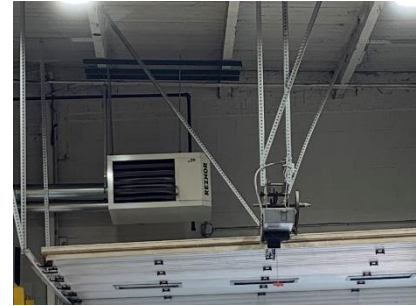
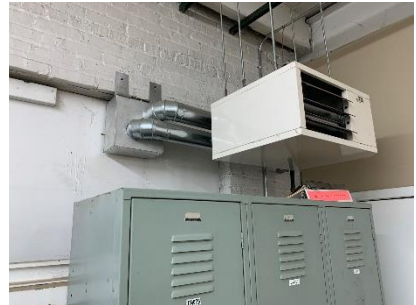
HVAC SYSTEMS

The existing mechanical system was observed to be a packaged gas fired air handler units. The units were in upper-level mezzanine above the training classroom for the office space. The units are operational, however were not able to be accessed at time of the observation.

The shop area utilizes gas fired unit heaters as identified below as well as a boiler system. The boiler was not operational at the time of the observation, however the age and use of the system appears to be in good working order.

The Reznor gas fired unit heaters were not operational at the time of this report, however, appear to be in good working order. Refer to manufacturer's recommendations on start-up sequence prior to full operations in the colder months.

The existing 1 ½" gas main appears to be sufficient for the type and use of the building.

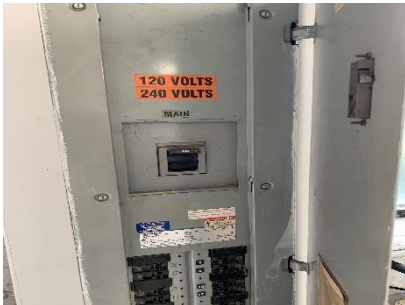
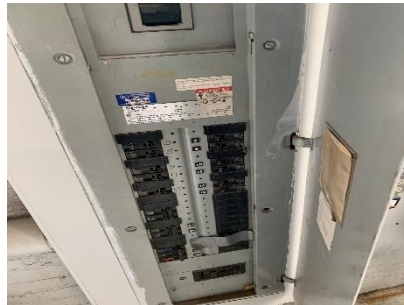
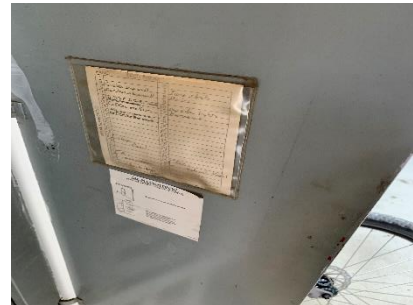
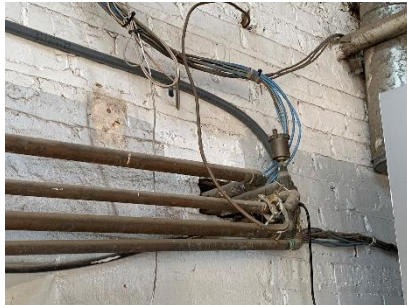
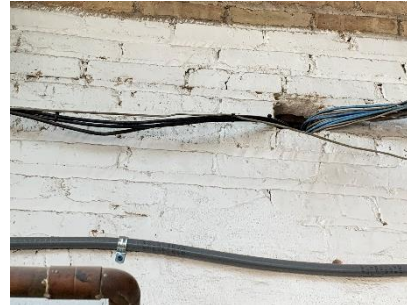
ELECTRICAL SYSTEMS

There are (4) 240-volt panelboards provided for equipment, lighting, and receptacles. The number of circuits available appears to be adequate for the base building. All equipment appears to be in good to fair condition.

The office areas and toilet rooms have typical 2'x4' T8 parabolic 3-lamp fixtures switched locally in each space. Lighting levels are average or above average in most areas. All lighting appears to be in good to fair condition.

The shop has typical 2'x4' T8 parabolic 2-lamp fixtures switched locally in each space. Lighting levels are average or above average in most areas. All lighting appears to be in good to fair condition.

Emergency and Exit lighting are provided at all exterior exit doors and interior areas. Emergency exit and lighting is provided by battery back-up unit with 90 minutes of reserve capacity. The exit and emergency lighting appears to be in good to fair condition. Battery testing and routine maintenance of all the installed battery units is recommended.

As currently configured, there is no noted compliance with current energy code requirements for local lighting controls, automatic controls, installed lighting power density, or daylight conservation. Lighting is controlled via centralized single switched on/off lighting contactors. A thorough review of the installed lighting components, fixtures, and controls in each space is recommended. A plan to upgrade the to enhance energy efficiency and comply with conservation code is recommended.

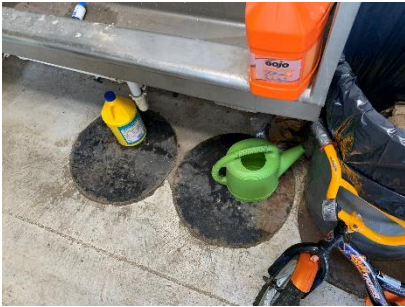
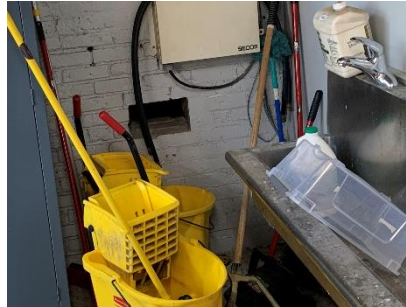
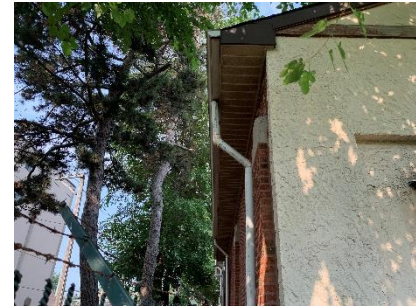
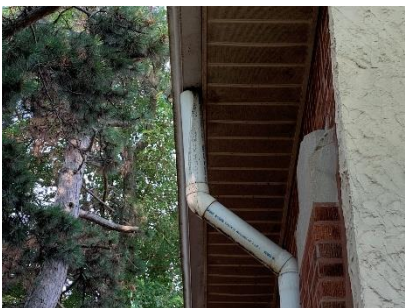
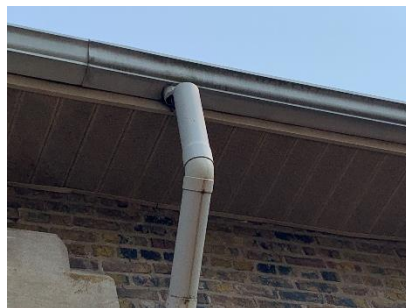
PLUMBING SYSTEMS

Plumbing fixtures appeared to be in fair condition. The lavatory faucets were lever handle design and did not appear to be of commercial grade construction, or the type normally found in commercial environments. The water closets were floor mounted. On the water closets observed, some chipping of the China was seen. Toilets and sinks appear to be a residential type. Triple basin was observed as well as the shop main shop sink. All appear operational in fair condition.

Hot water tank in the shop appears to be replaced within the past 5 years. It appears in good working order.

The building is not sprinklered.

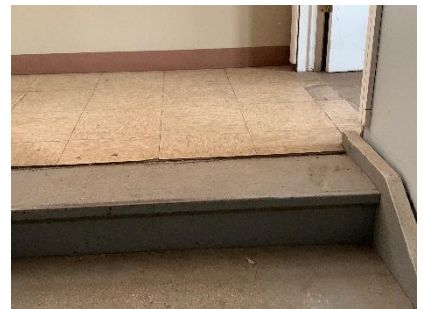
ACCESSIBILITY

There are major ADA deficiencies observed at the facility compared with the latest 2018 (IAC) Illinois Accessibility Code. Some following observations are listed below:

Toilet Rooms are undersized based on turning radius and reaches.

No accessible entry is identified.

All entries into the main office are raised.

Door height sill is raised and does not meet the ½" max threshold requirement.

The existing building has various levels with the first floor. No provision for accessible route on the interior of the building exists.

Various door clearances in the office do not meet the push/pull clearance requirements.

No lavatory anti/scald guards are present in the toilet rooms.

Shower size and fixtures are not accessible.

No grab bars or reinforcing of grab bars are in the toilet rooms.

Location of Toilet and Bath Accessories are not in accessible reach ranges.

No provisions for accessibility to workshop on mezzanine level.

Workshop stair railing is not accessible.
