**GLEN ELLYN PARK DISTRICT
FRANK JOHNSON CENTER
FACILITIES MASTERPLAN**

Facilities Master Plan

September 24, 2021

This existing facility condition review identifies deficiencies and defects of site and building that may impact current or future operations. The review was performed in general conformance with ASTM E 2018 - 15, Standard Guide for Property Condition Assessments: Baseline Property Condition Assessment Process.

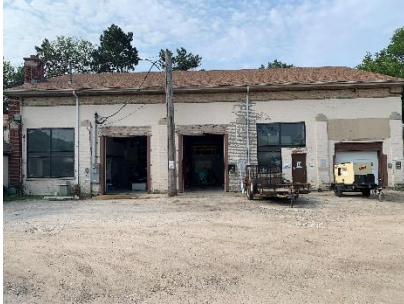
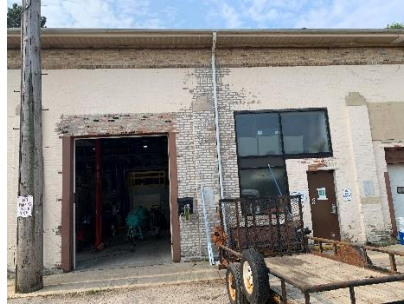
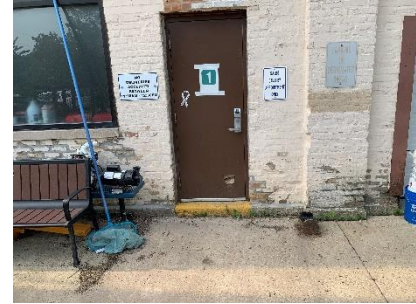
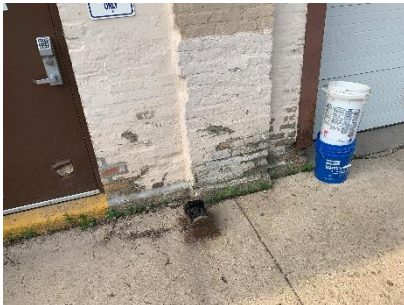
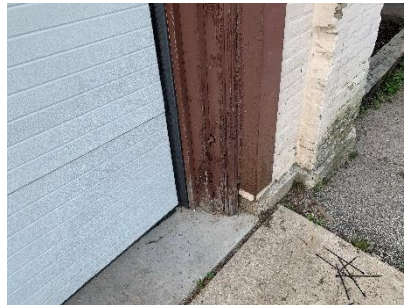
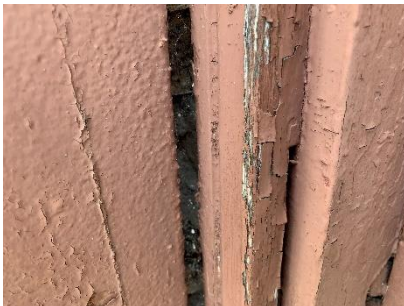
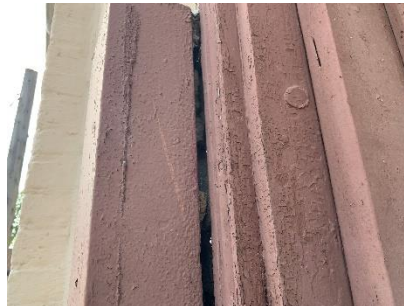
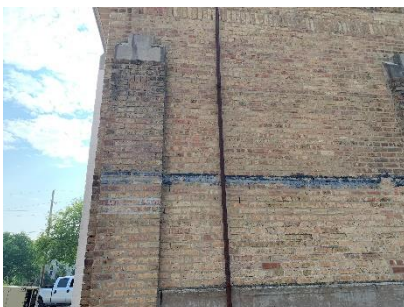
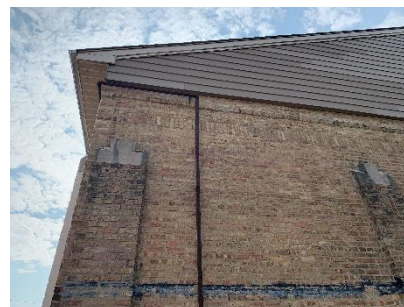
EXTERIOR WALLS

The original structure consists of exterior load bearing 3 wythe thick masonry walls with masonry buttresses along the north, south and west facades. The shop portion of the structure consists of a painted/ exposed common brick exterior finish. The following photos in section 3.1 will identify specific areas of deficiency. The overall exterior wall on the main building is in fair to poor condition, areas of cracked brick, missing bricks, multiple open masonry joints, spalling concrete were all observed. Additional information will be discussed in Section 5. The western masonry façade on the main building appears to be bowing and bulging outward. Exterior siding appears to be oil canning and missing in several locations. Exterior paint is flaking and cracking along all exterior jambs. Complete removal of paint, proper priming and reapplication will be required. Plywood infill panels along the southern façade appear to be rotting and failing in various areas. Window on south façade is broken. Exposed glass should be removed.

The eastern office portion of the structure exterior wall make up is a stucco and wood façade with clay fired masonry face brick. Efflorescence was observed on the southern portion of the office area. Wood timbers appear sun faded but in good condition. Stucco finish appears in good condition. Failed sealant around windows was observed.

Exterior walls of storage garage to the west were observed to be in good condition. The exterior wall make up is a PBR metal panel and girt system with vinyl backed mineral wool insulation. Metal panels appear in good condition.

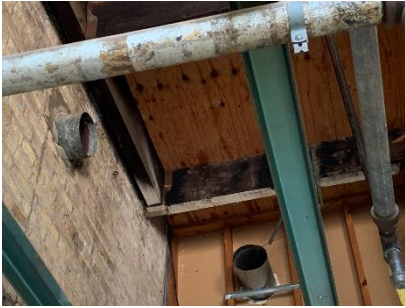
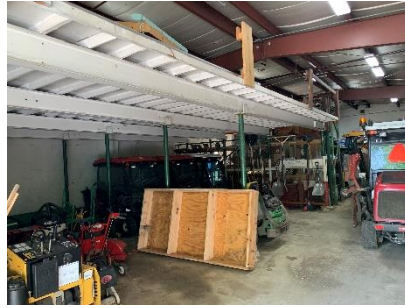
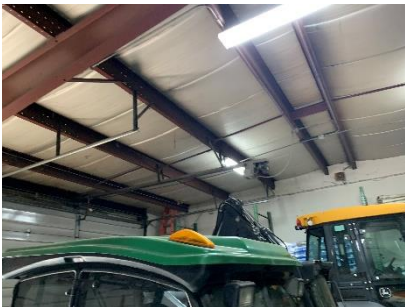
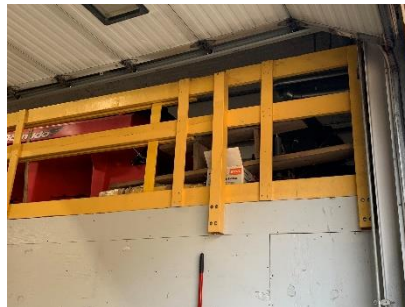
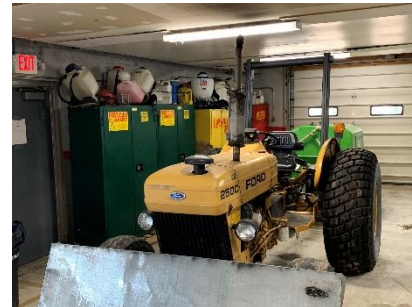
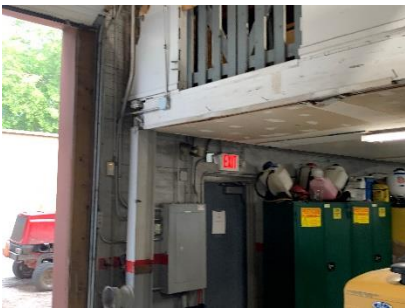
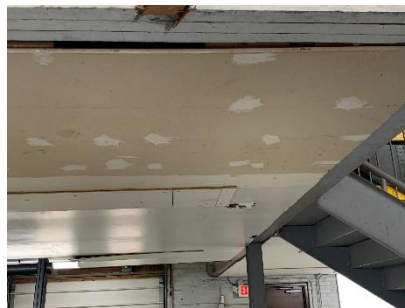
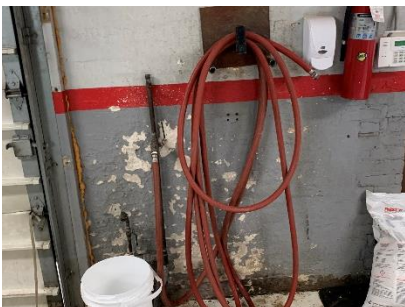
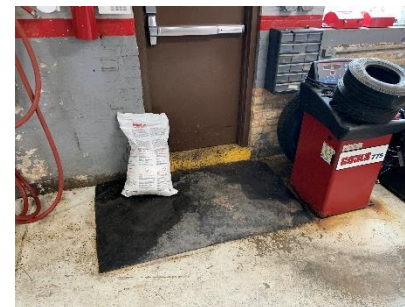
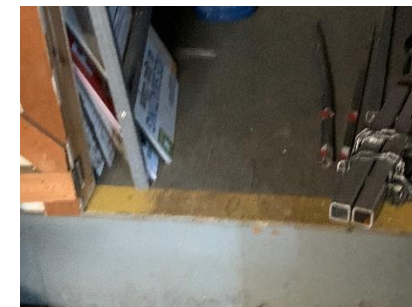
INTERIORS

The interiors of this building as observed demonstrated an extended life span of use. The existing shop concrete floor would benefit from a repair and replacement in multiple areas of the floor with an entire sealer on the floor recommended. The main shop has various levels of paint deficiency, from peeling and cracking to complete failure. The entire interior of the shop would benefit from a repaint.

Interior gypsum walls appear in good condition.

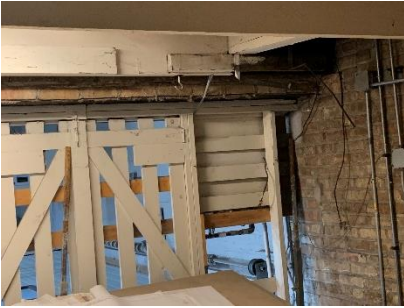
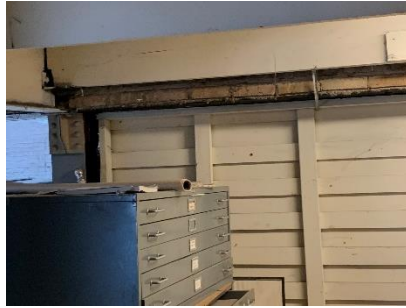
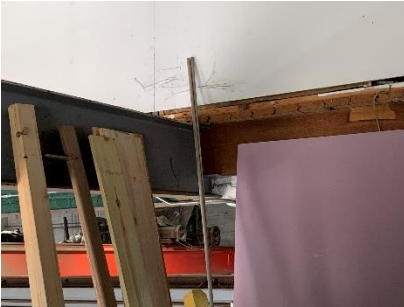
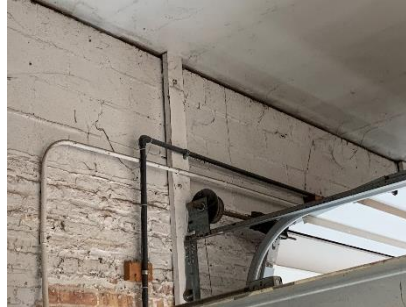
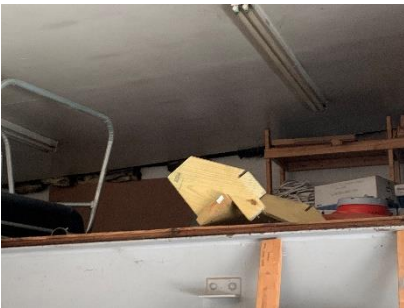
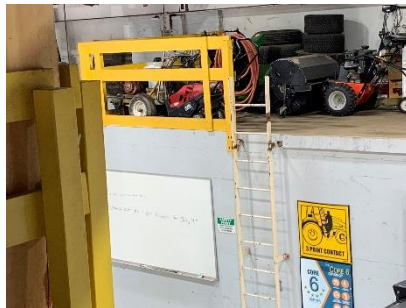
The interior office interiors are in fair/poor condition. There are various levels of staining and damage to the existing floor surface. The interior ceiling tile system has failed in certain areas and are stained due to apparent water leaks. The ceilings in the damaged areas should be replaced to a good working order. Additional remedial work may be necessary once determination of the leaks are identified.

Interior doors are residential grade doors and show signs of damage and wear. We recommend installing commercial grade doors and frames.

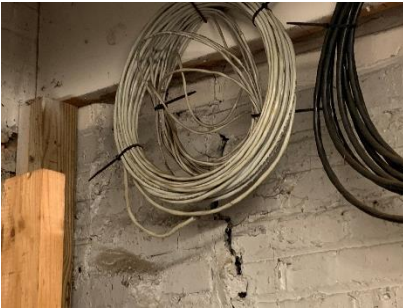
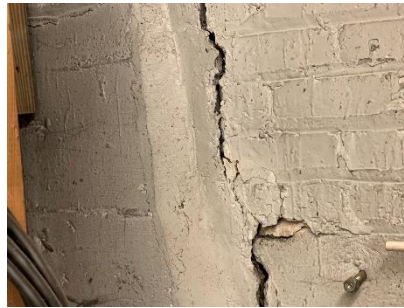
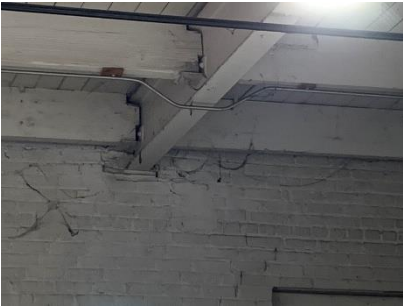
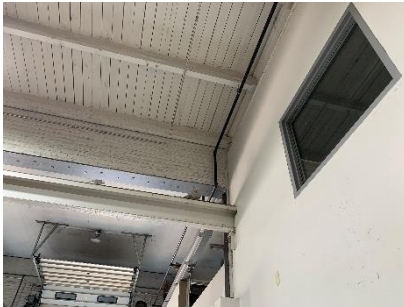
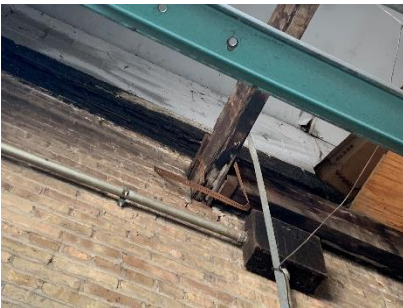
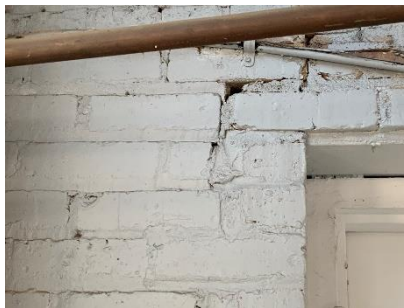
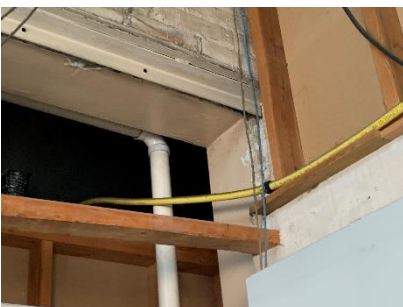
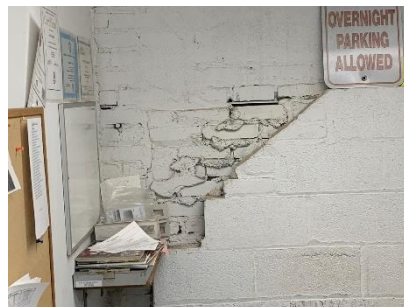
STRUCTURAL

A differential crack was noted in the southwest corner of the shop. Remediation is required at this location.

Various cracking occurring at masonry beam supports in the existing masonry walls.

Various areas of water infiltration on the interior of the building are causing mortar wash out on interior.

Metal column base plates and columns are observed with layers of rust. The exact amount of decay is unknown.

The existing structure of the building appears to have deficiencies beyond the age and style of the building. We recommend a detailed review and analysis by a licensed structural engineer. Some observations noted in our review are as follows:

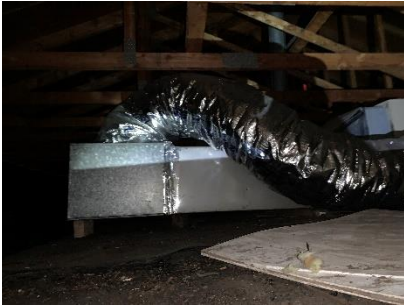
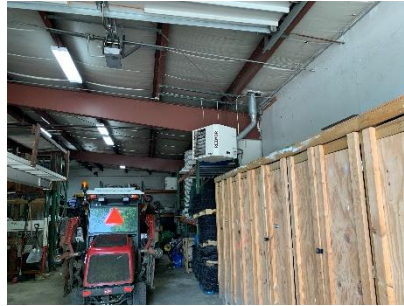
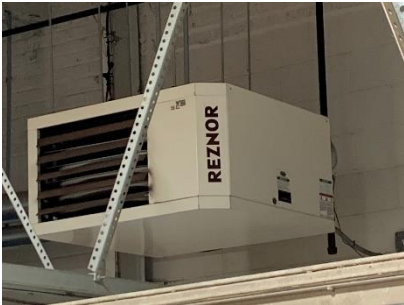
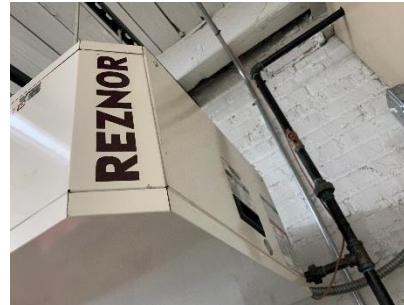
HVAC SYSTEMS

The existing mechanical system was observed to be a packaged gas fired air handler units. The units were in upper-level mezzanine above the training classroom for the office space. The units are operational, however were not able to be accessed at time of the observation.

The Reznor gas fired unit heaters were not operational at the time of this report, however, appear to be in good working order. Refer to manufacturer's recommendations on start-up sequence prior to full operations in the colder months.

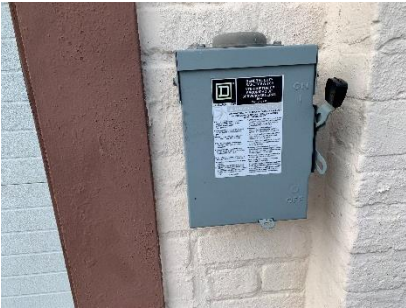
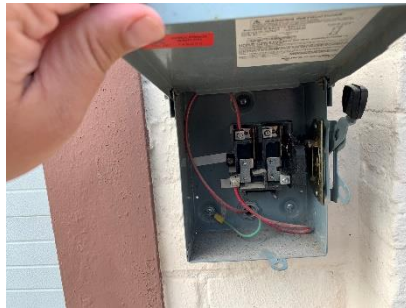
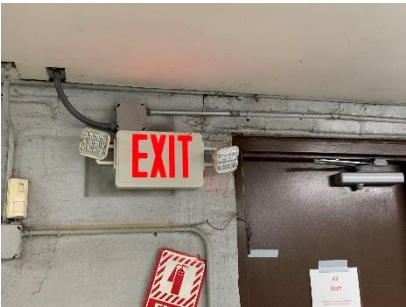
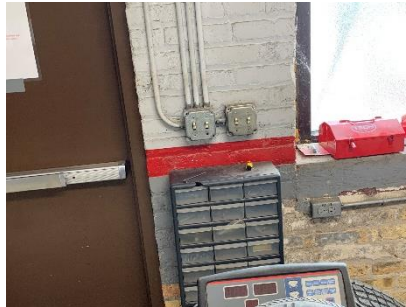
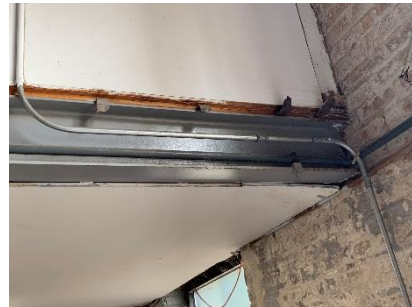
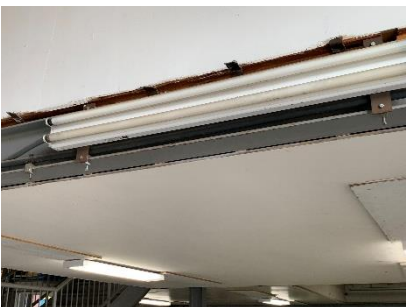
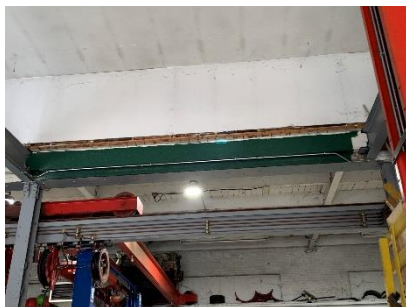
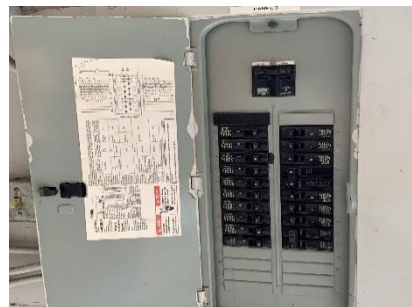
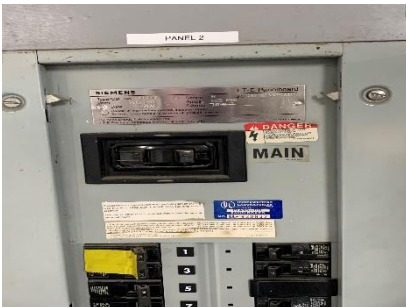
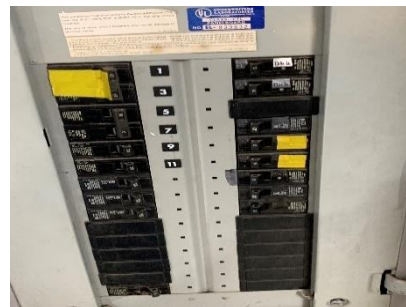
ELECTRICAL SYSTEMS

There are (4) 240-volt panelboards provided for equipment, lighting, and receptacles. The number of circuits available appears to be adequate for the base building. All equipment appears to be in good to fair condition.

The office areas and toilet rooms have typical 2'x4' T8 parabolic 3-lamp fixtures switched locally in each space. Lighting levels are average or above average in most areas. All lighting appears to be in good to fair condition.

The shop has typical 2'x4' T8 parabolic 2-lamp fixtures switched locally in each space. Lighting levels are average or above average in most areas. All lighting appears to be in good to fair condition.

Emergency and Exit lighting are provided at all exterior exit doors and interior areas. Emergency exit and lighting is provided by battery back-up unit with 90 minutes of reserve capacity. The exit and emergency lighting appears to be in good to fair condition. Battery testing and routine maintenance of all the installed battery units is recommended.

The building has an existing phone/data service and distribution board located within the office which appears adequate for the current usage. All equipment appears to be in good to fair condition.

As currently configured, there is no noted compliance with current energy code requirements for local lighting controls, automatic controls, installed lighting power density, or daylight conservation. Lighting is controlled via centralized single switched on/off lighting contactors. A thorough review of the installed lighting components, fixtures, and controls in each space is recommended. A plan to upgrade the to enhance energy efficiency and comply with conservation code is recommended.

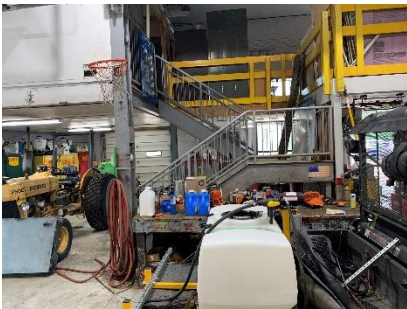
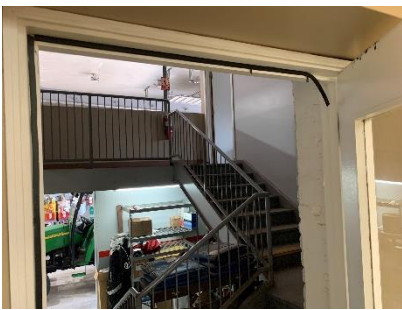
ACCESSIBILITY

There are major ADA deficiencies observed at the facility compared with the latest 2018 (IAC) Illinois Accessibility Code. Some following observations are listed below:
