## Ackerman SFC Parking Lot Update: 8/6/18 to 8/10/18

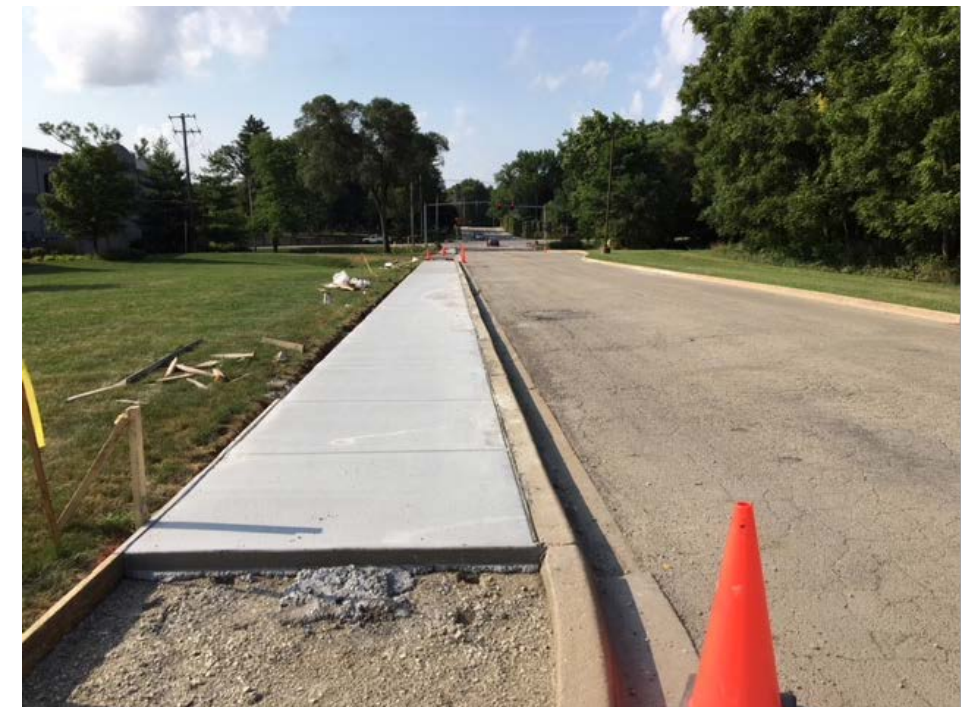
- Sections of the new concrete sidewalk that runs along the Ackerman SFC entrance drive have been installed. There was an issue with the curb cuts at the intersections not conforming to ADA standards, so these sections had to be re-engineered. The remaining concrete sidewalk will be installed next week.

- The surveying and layout for the ribbon curb and parking lot islands has been performed.
- The drainage system has been installed in the Ackerman SFC parking lot. The drainage system is designed to capture excess water that makes its way into the permeable paver section and convey it into the detention basin in front of the Ackerman SFC building.

- A large, ornamental boulder that was situated next to the Ackerman SFC entrance drive sidewalk has been moved into Ackerman Woods. The boulder was most likely discovered during the construction of Ackerman SFC and placed along the sidewalk at that time. The boulder's new location is much more appropriate and compliments the natural area.

- Excavation for the ribbon curb and parking lot islands has been completed. The concrete crew will form and pour the new concrete curbing next week.
- Once the ribbon curb has had time to cure, the stone base will be added and the new permeable pavers can be installed.
- The remaining concrete sidewalk will be installed along the Ackerman SFC entrance drive.
- New conduit and wiring will be installed, and the parking lot light poles will be relocated.
- When the Ackerman SFC parking lot portion is nearing completion, the asphalt crew will begin to grind and overlay portion of the Ackerman SFC entrance drive. During this process, traffic may have to be diverted to the east entrance of Ackerman Park for a few days. Staff will provide notification as early as possible and will provide signage to assist patrons during this phase.
